Docket No. 217 – Development and Management Plan Inspection

Northeast Utilities Service Company Certificate of Environmental Compatibility and Public Need for the construction of a 345-kV electric transmission line and reconstruction of an existing 115-kV electric transmission line between Connecticut Light and Power Company's Plumtree Substation in Bethel, through the towns of Redding, Weston, and Wilton, and to the Norwalk Substation in Norwalk, Connecticut.

Date: March 16, 2006

Location: 115 kV Underground Route

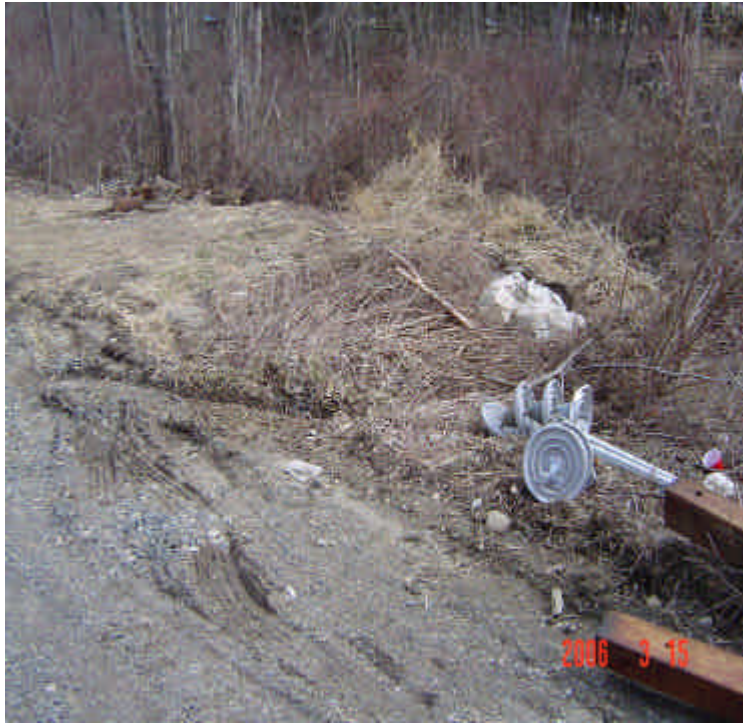
115kV (Hoyts Hill and Sunset Hill Rd): Photo on the left shows the riser pole area across from Hoyts Hill where some materials were left behind. It was unclear if this was resulting from the 115kV work. Photo on the right shows the Sunset Hill storage area with good controls. 3/16/06

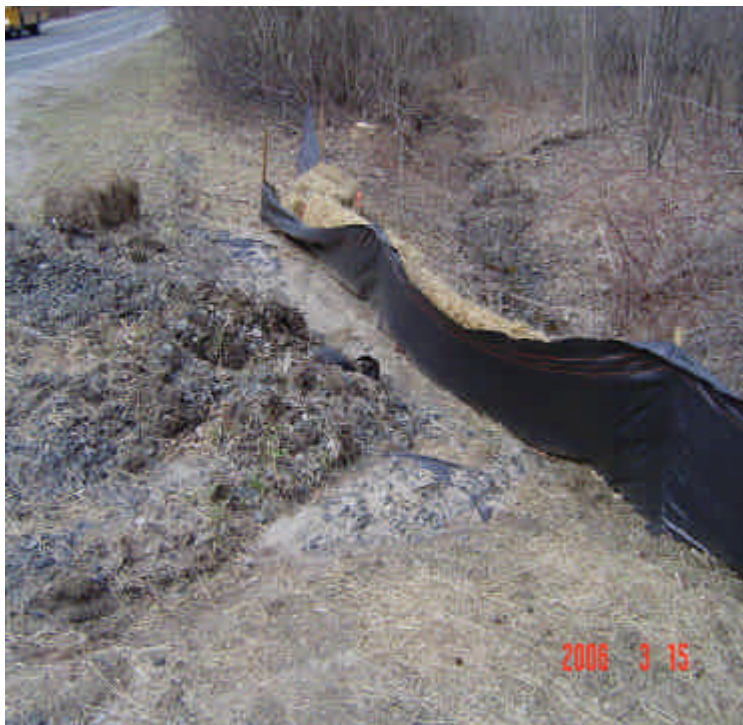
115kV (Sunset Hill and Putnam Park): Photo on the left shows where controls remain in good shape at Sunset Hill even with some sediment run off to this spot. Photo on the right shows good controls remaining at Putnam Park storage area. The stream beyond is well protected. 3/16/06
